**FIVE-YEAR REVIEW REPORT**

**Second Five-Year Review Report  
For  
Wheeler Pit Site  
La Prairie Township, Wisconsin**

**September 2002**

**PREPARED BY:  
United States Environmental Protection Agency  
Region 5  
Chicago, Illinois**

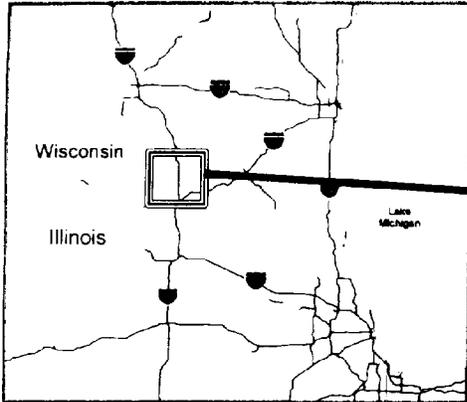
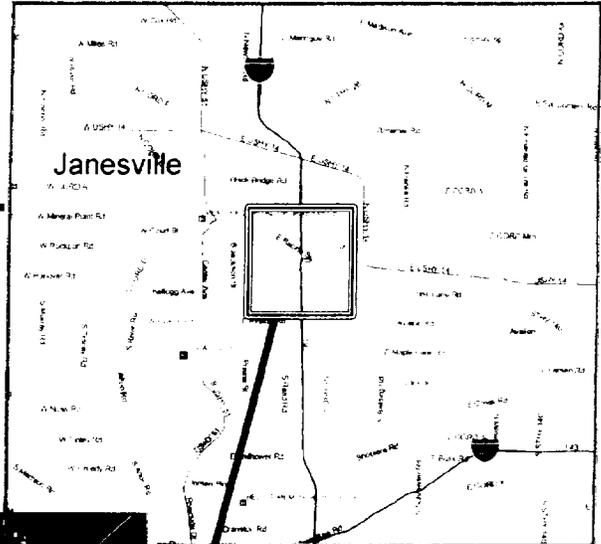
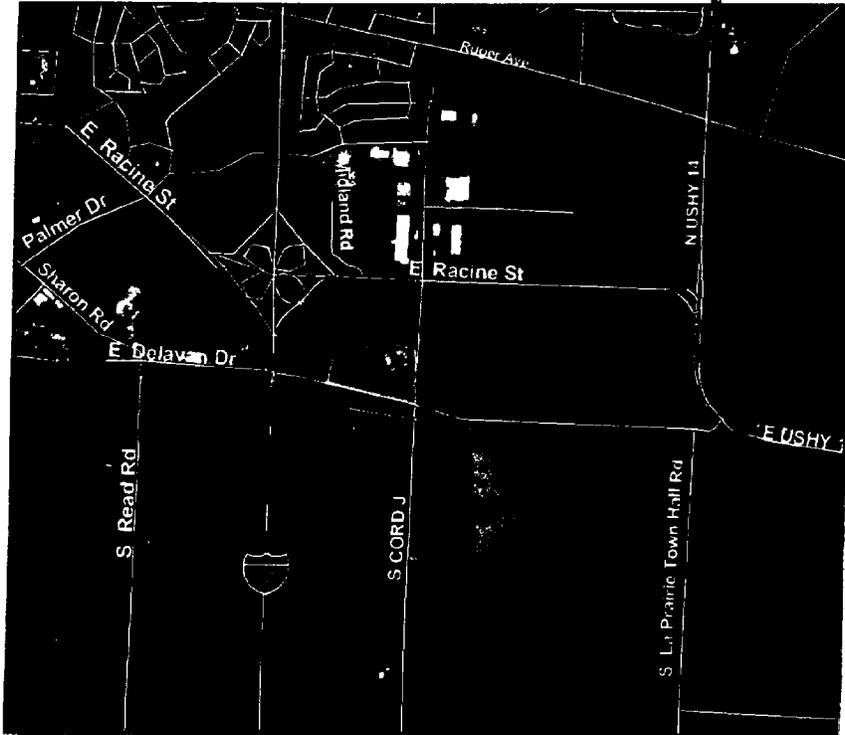
Figure 1

# Wheeler Pit Superfund Site Rock County, Wisconsin

1) State

2) City of Janesville

3) Wheeler Pit Superfund Site

The Site is located in rural La Prairie Township approximately 1 ½ miles east of the City of Janesville, Wisconsin, directly northwest of the intersection of County Highway O (Old Delevan Road) and County Highway J. (See Figures 1 and 2). The Site is within a physical depression approximately 50 feet deep and spanning an area of approximately 35 acres, which previously operated as a sand and gravel pit by the Southeast Railway Company and the Chicago, Milwaukee, St. Paul, and Pacific Railroad Company (CMC). In 1956, General Motors Corporation (GM) leased a portion of the pit area from the railroad for waste disposal. This portion of the pit area is the Wheeler Pit Superfund Site and is a 3.82 acre parcel in the southeast portion of Wheeler Pit which was used as a disposal area for industrial wastes for approximately

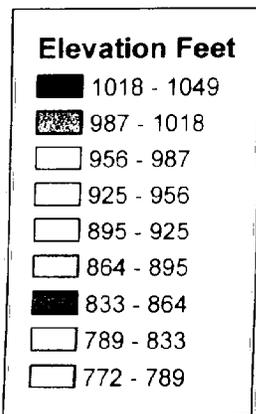
Figure 2

# Wheeler Pit Superfund Site 3D Surface Terrain Model

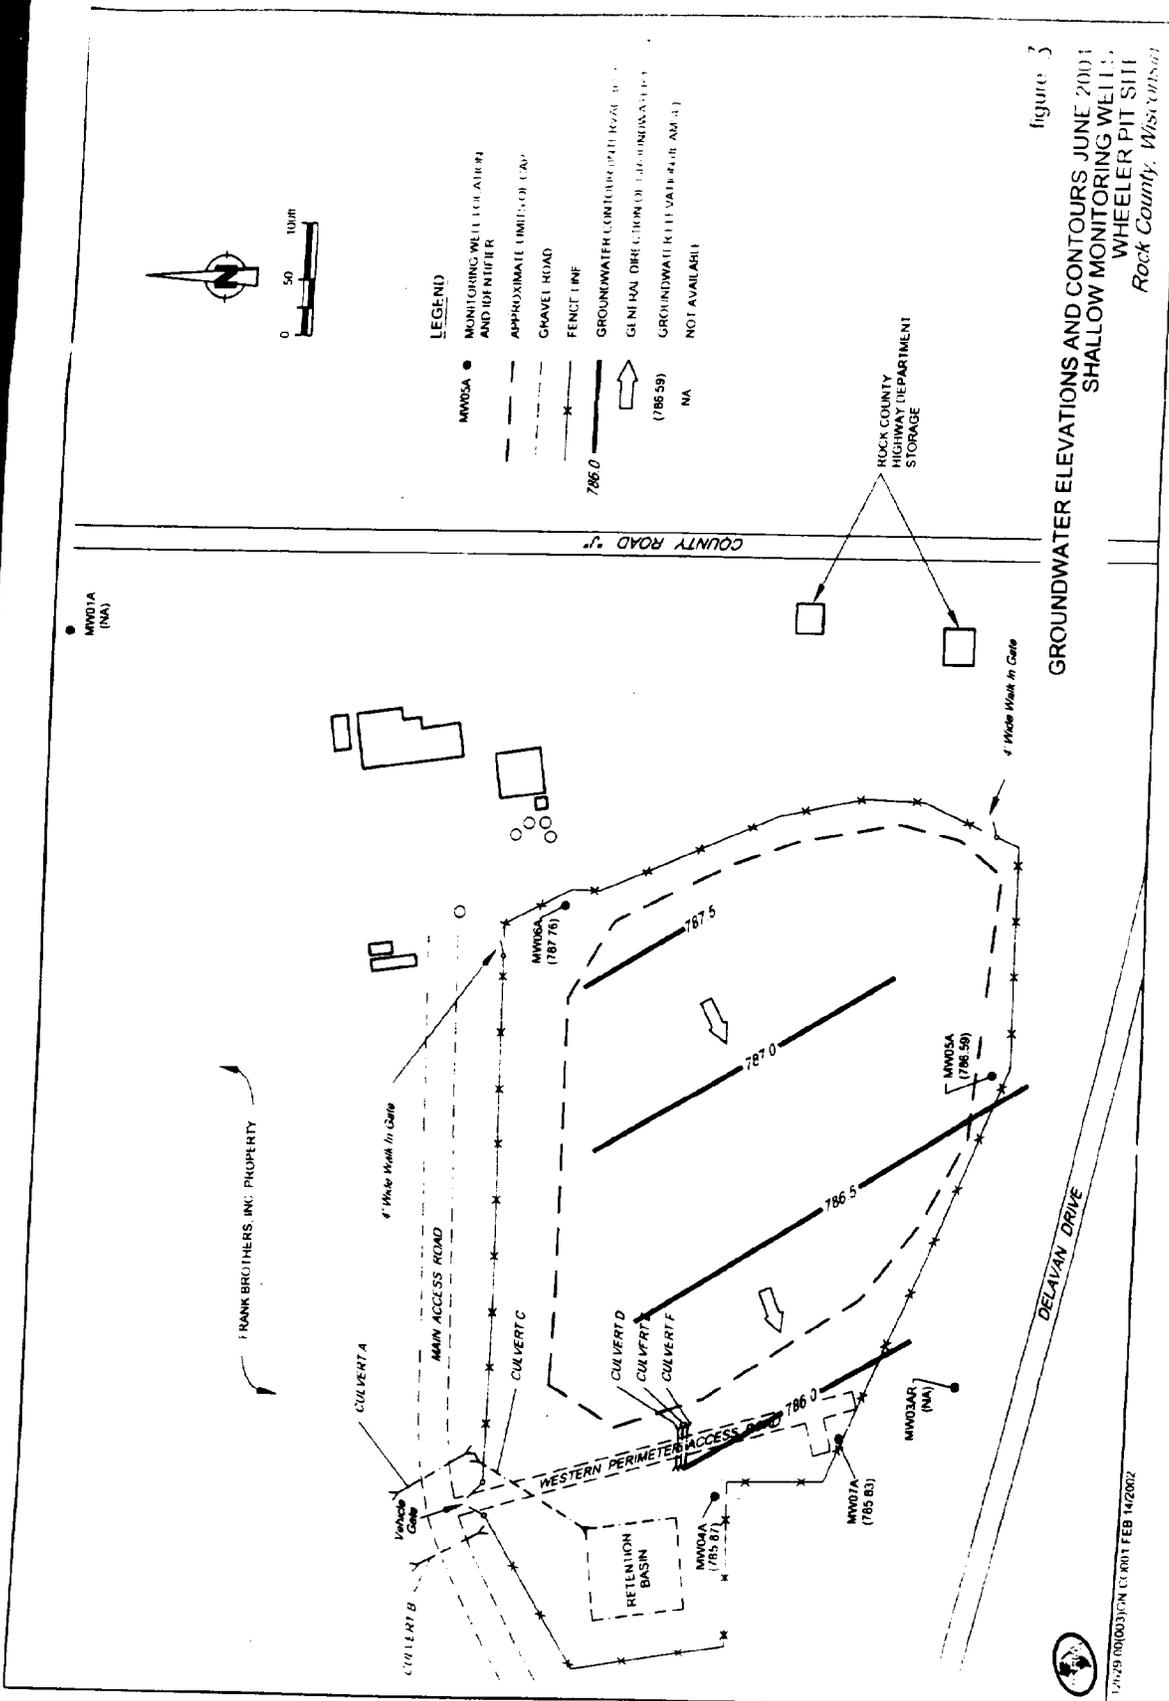
figure 3  
 GROUNDWATER ELEVATIONS AND CONTOURS JUNE 2001  
 SHALLOW MONITORING WELL:  
 WHEELER PIT SILT  
 Rock County, Wisconsin

Given that the Five Year Groundwater Assessment Report demonstrated that only one contaminant of concern (manganese) in one downgradient well exceeded the WDNR PALs, U.S. EPA approved a reduced groundwater monitoring program for the future annual site groundwater sampling. The reduced monitoring program consists of sampling for manganese in four monitoring wells, which are downgradient monitoring wells MW7A and MW 3A, upgradient monitoring well MW6A and sidegradient monitoring well MW 5A (See Figure 3).
